2011 Basin Highlights Report for the Rio Grande Basin in Texas

An update on Water Quality and Basin Activities

International Boundary and Water Commission, U.S. Section,
Texas Clean Rivers Program

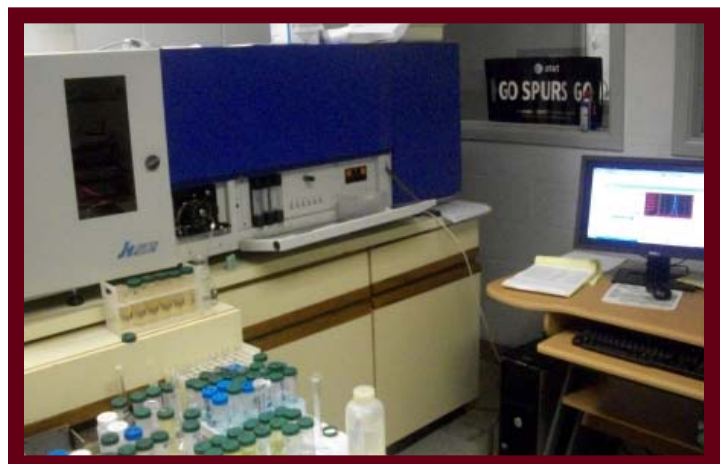
A mass spectrometer used to analyze metals and inorganic compounds at Alamo Analytical Laboratories

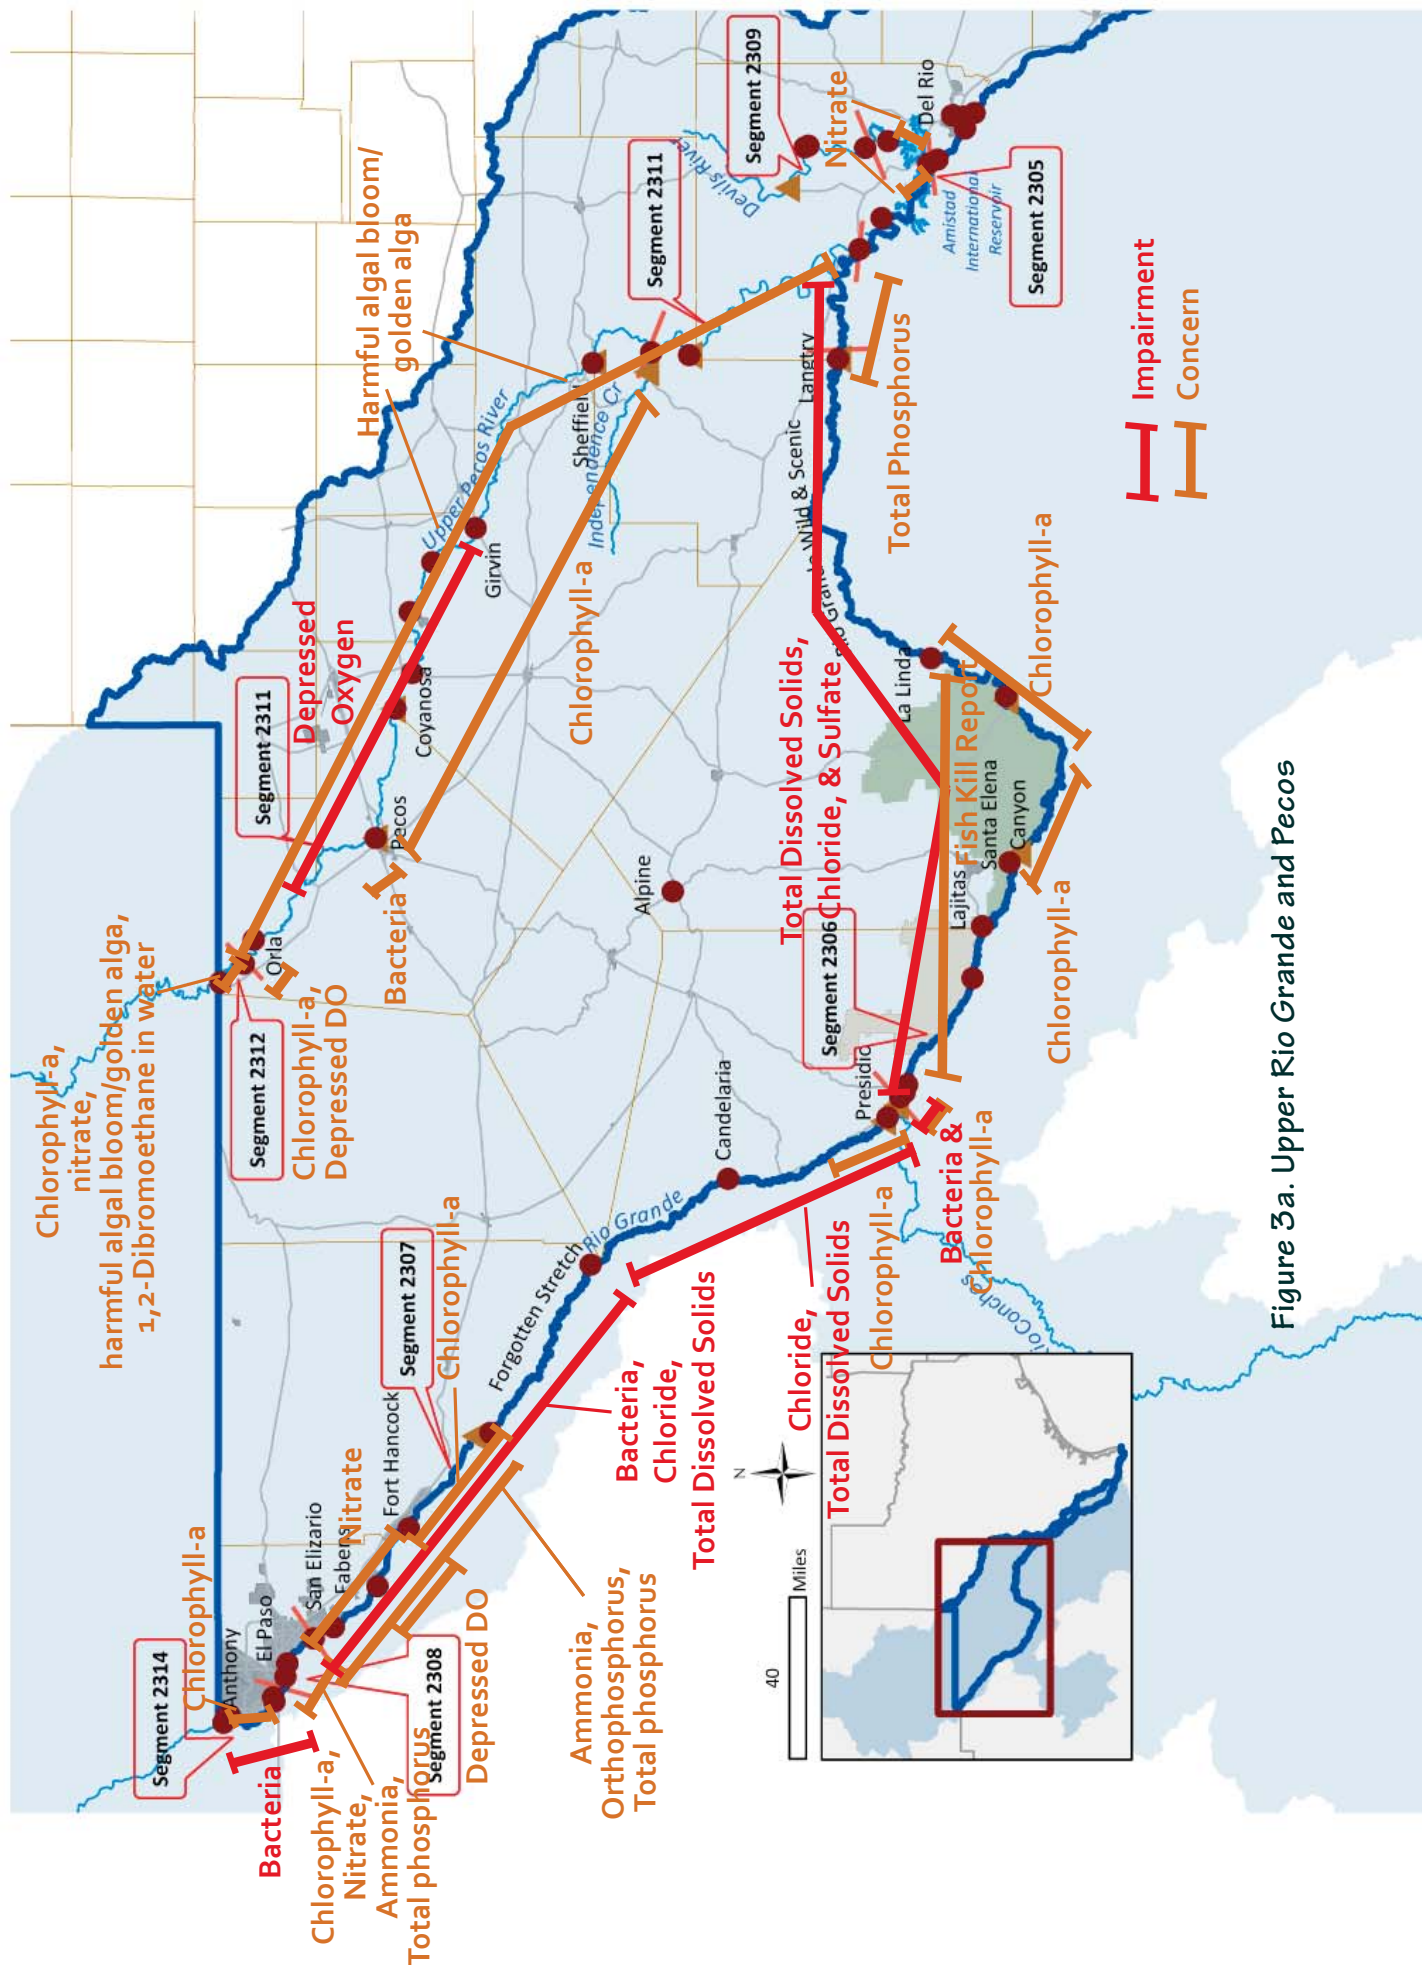
Figure 3a. Upper Rio Grande and Pecos

Figure 3a. Water Quality Impairments and Concerns in the Rio Grande Basin

Major water quality issues throughout the basin include bacteria and salinity. **Impairments and concerns in the Rio Grande Basin are listed in Table 5 and shown in Figure 3 (a-c).** The Draft 2010 Integrated Report lists additional segments as impaired from the 2008 Integrated Report. River water with high bacteria levels may pose health risks to swimmers and other recreational users. High salinity can damage crops, is expensive to treat for drinking, and is harmful to freshwater fish and aquatic invertebrates. USIBWC CRP is committed to collecting the necessary water quality information so that the appropriate authorities can make decisions pertaining to water quality issues.

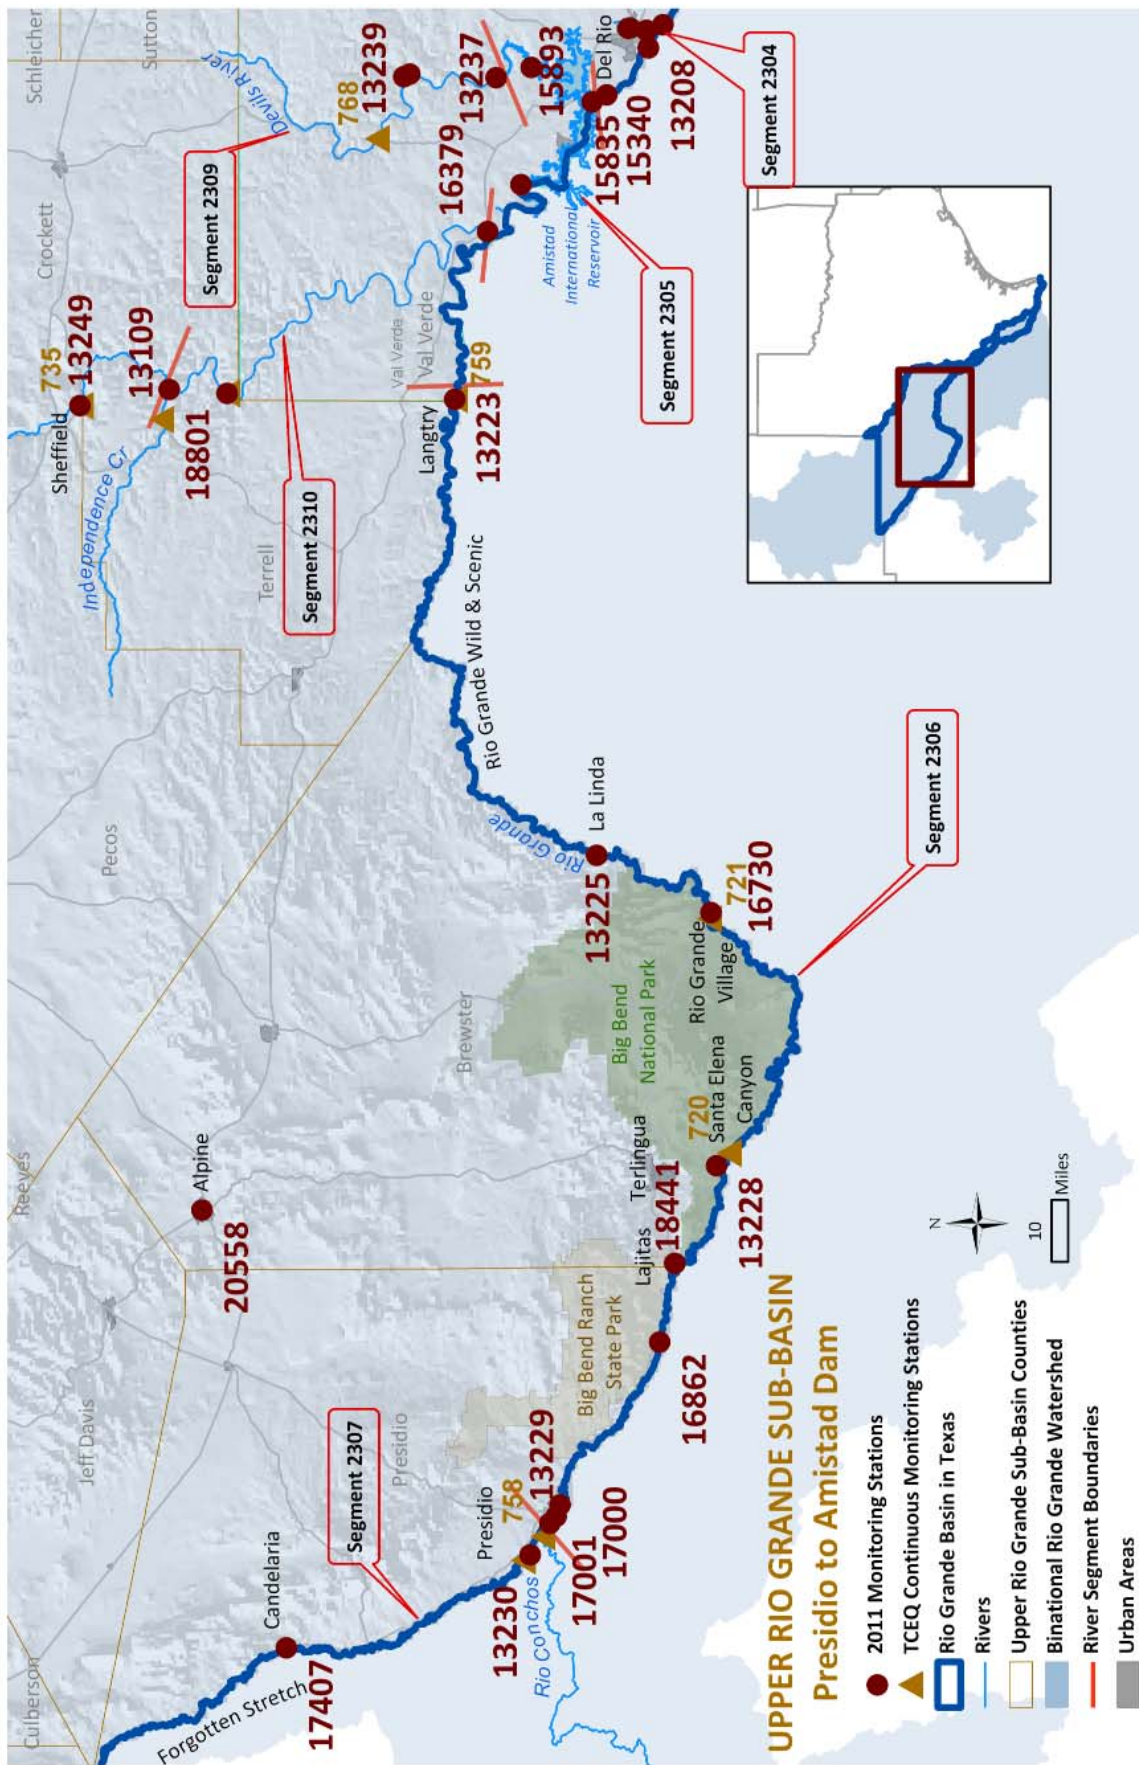
Figure 4b. Upper Rio Grande Sub-Basin Station Map
b) Presidio to Amistad Dam

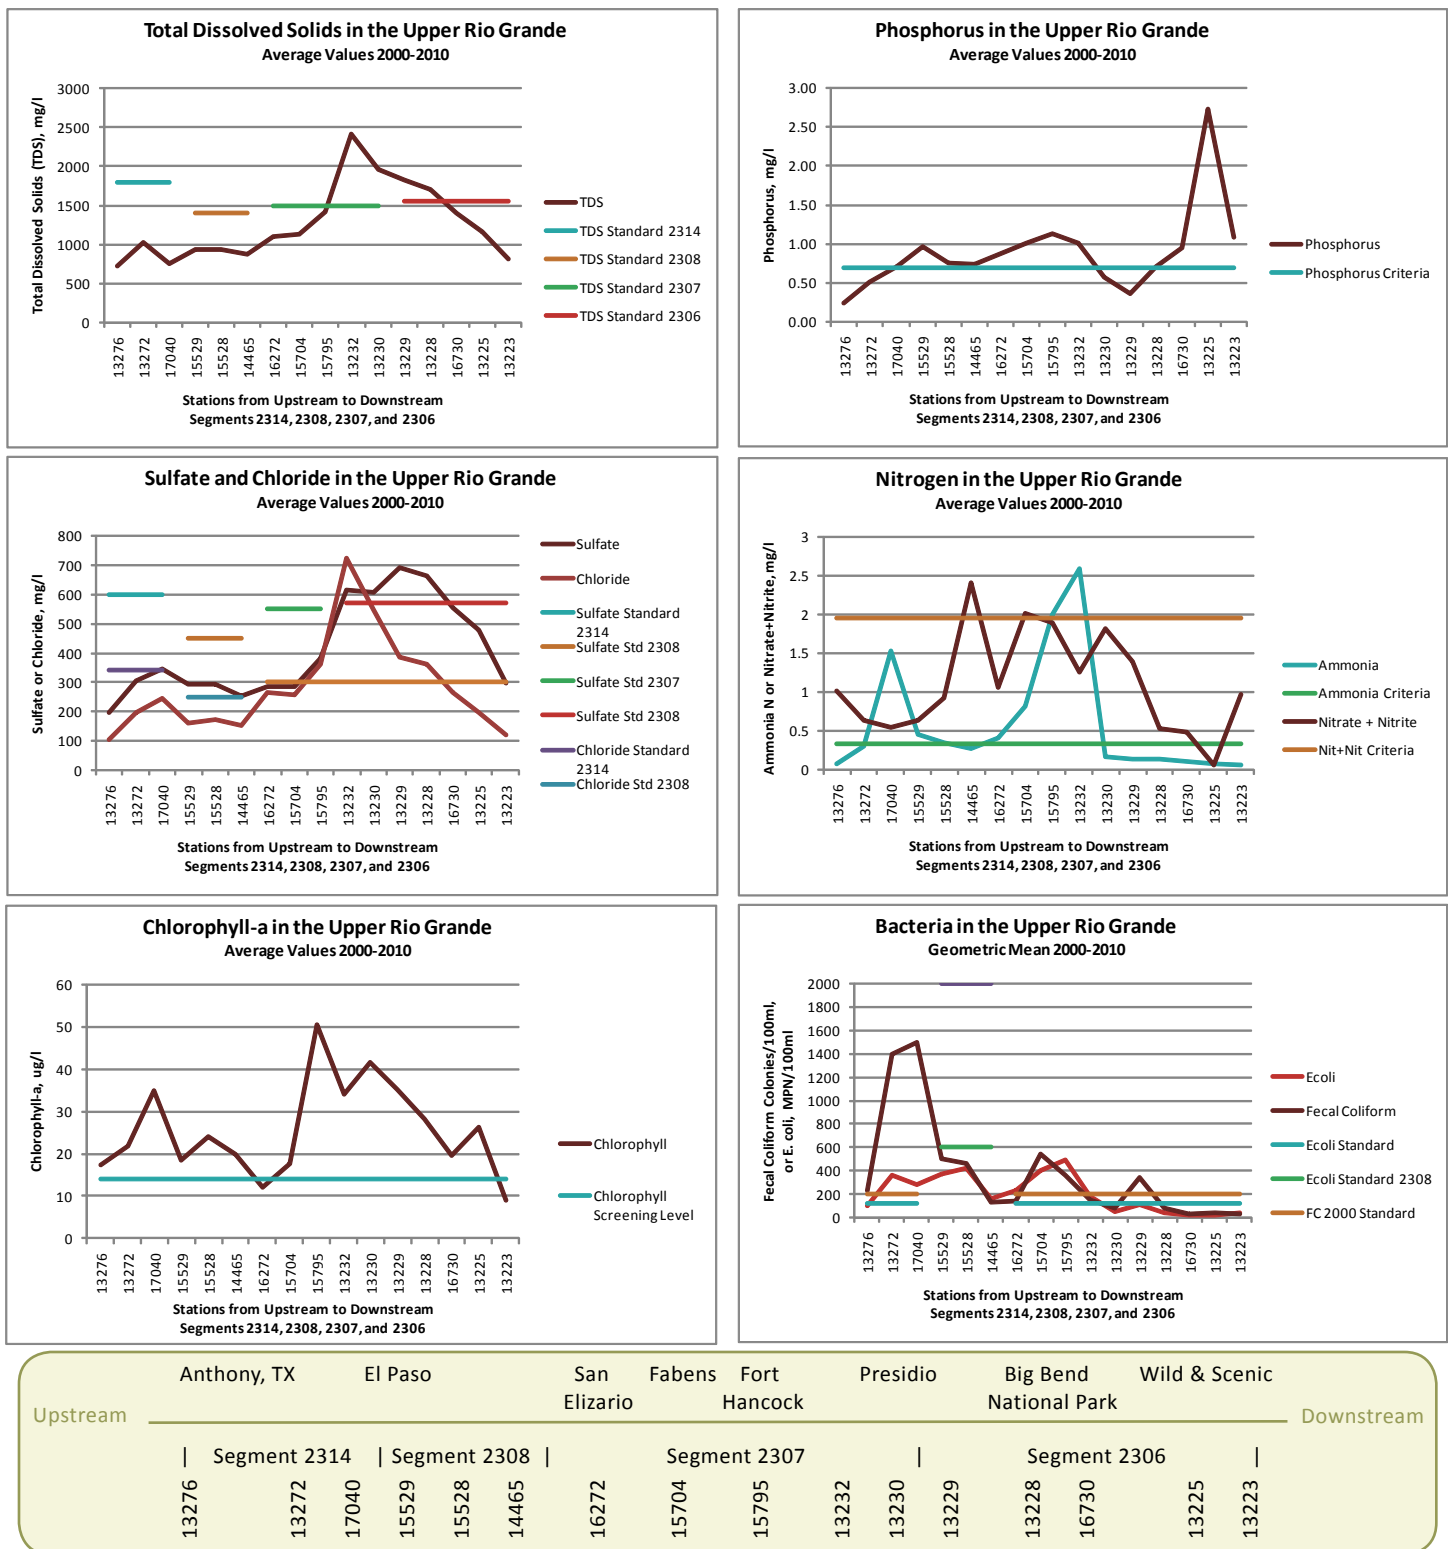
Figure 5. Graphs of major water quality parameters in the Upper Rio Grande

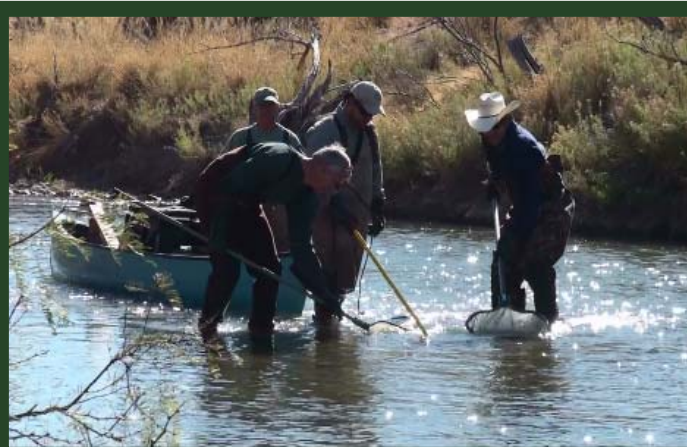
Field crews collect fish via electrofishing method at Station 13249 near Sheffield, December 2010

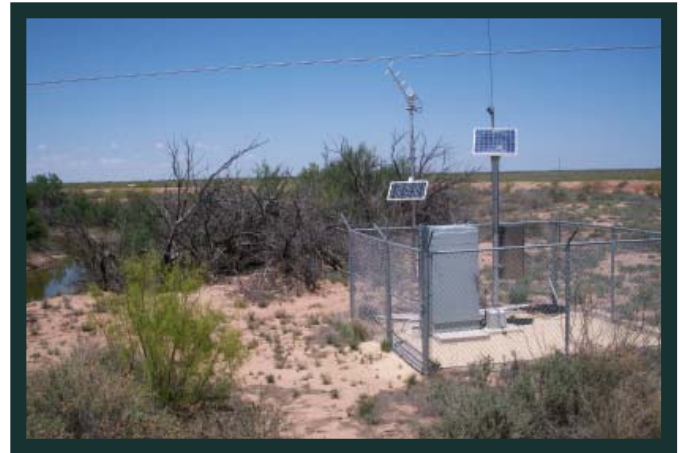
The continuous water quality monitoring station on the Pecos at Pecos, TX, April 2010

The TCEQ currently operates six CWQM stations on the Pecos River and will soon be expanding its network to eight. The data generated is being used to monitor changes in salt concentrations (using specific conductance) and surface water flow associated with salt cedar removal, to collect data to support research on the cause of toxic golden alga blooms, to provide data for the Integrated Report, and to support the Pecos River WPP by monitoring dissolved oxygen. The two new sites will be installed at Girvin, TX and Red Bluff, NM in support of the WPP.

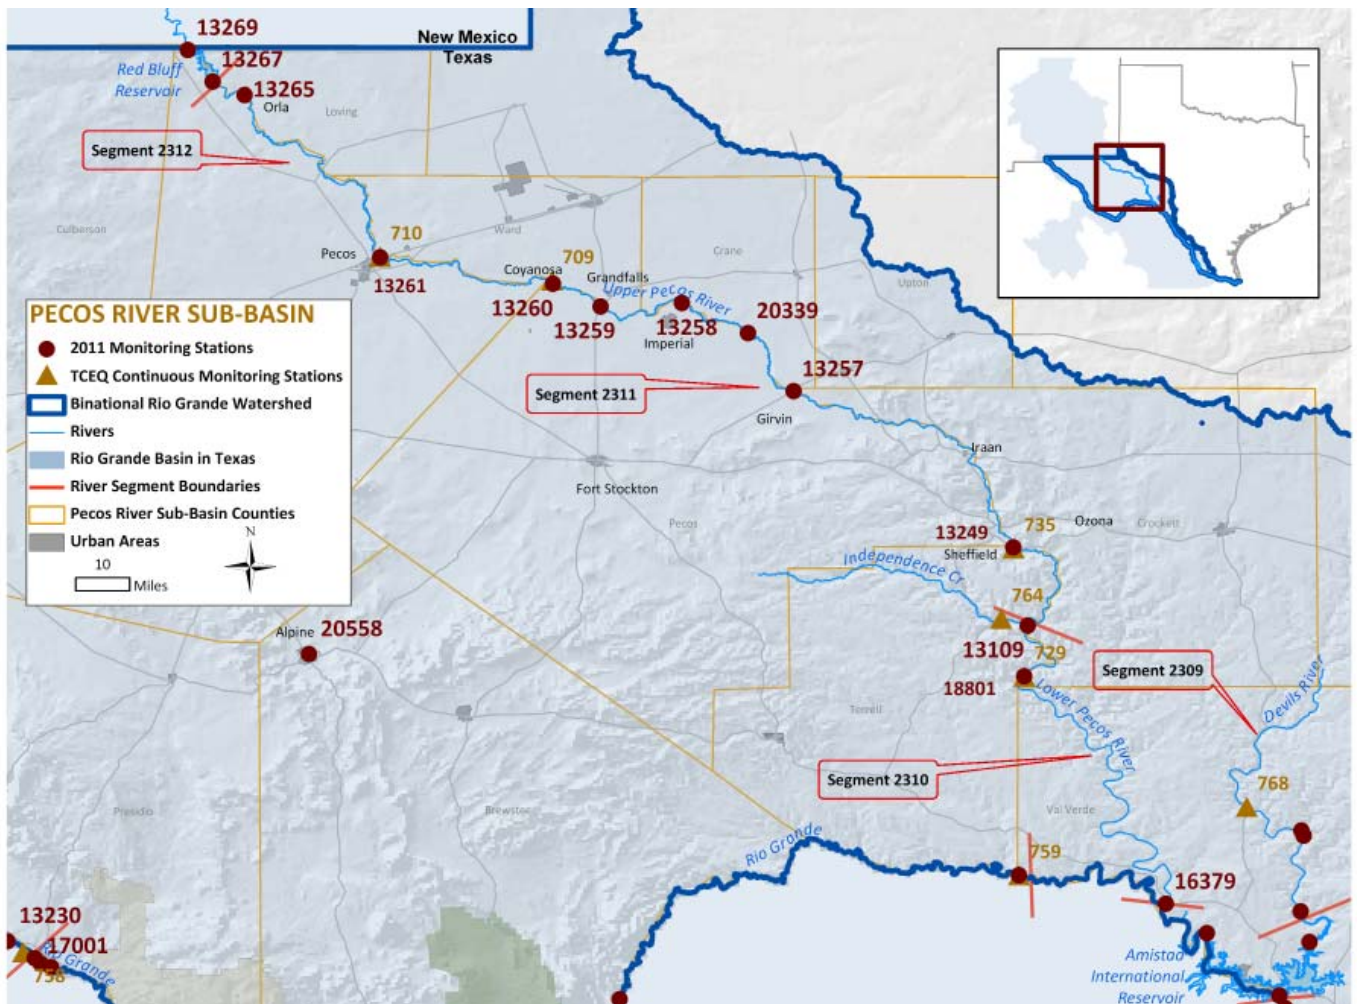
Figure 6. Pecos River Sub-Basin Station Map

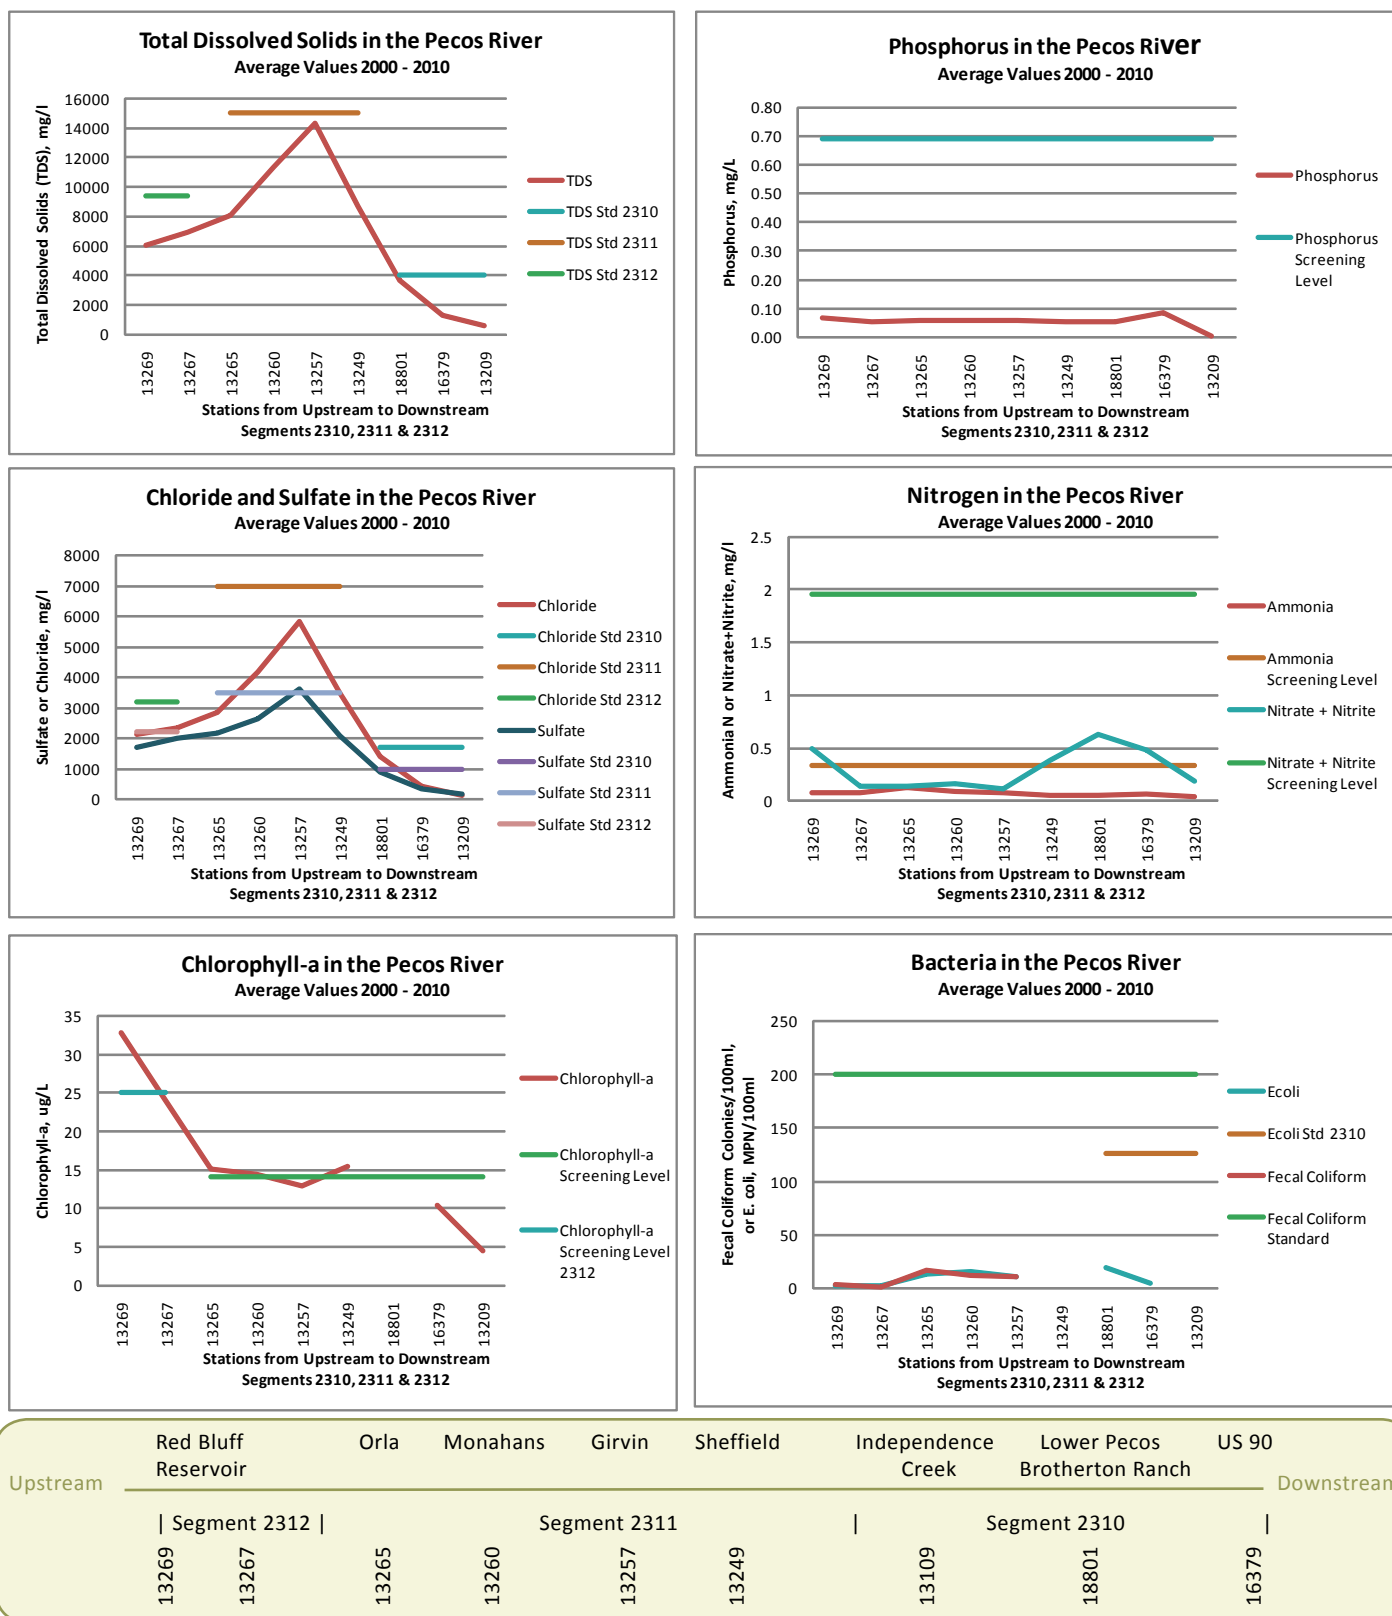
Figure 7. Graphs of major water quality parameters in the Pecos

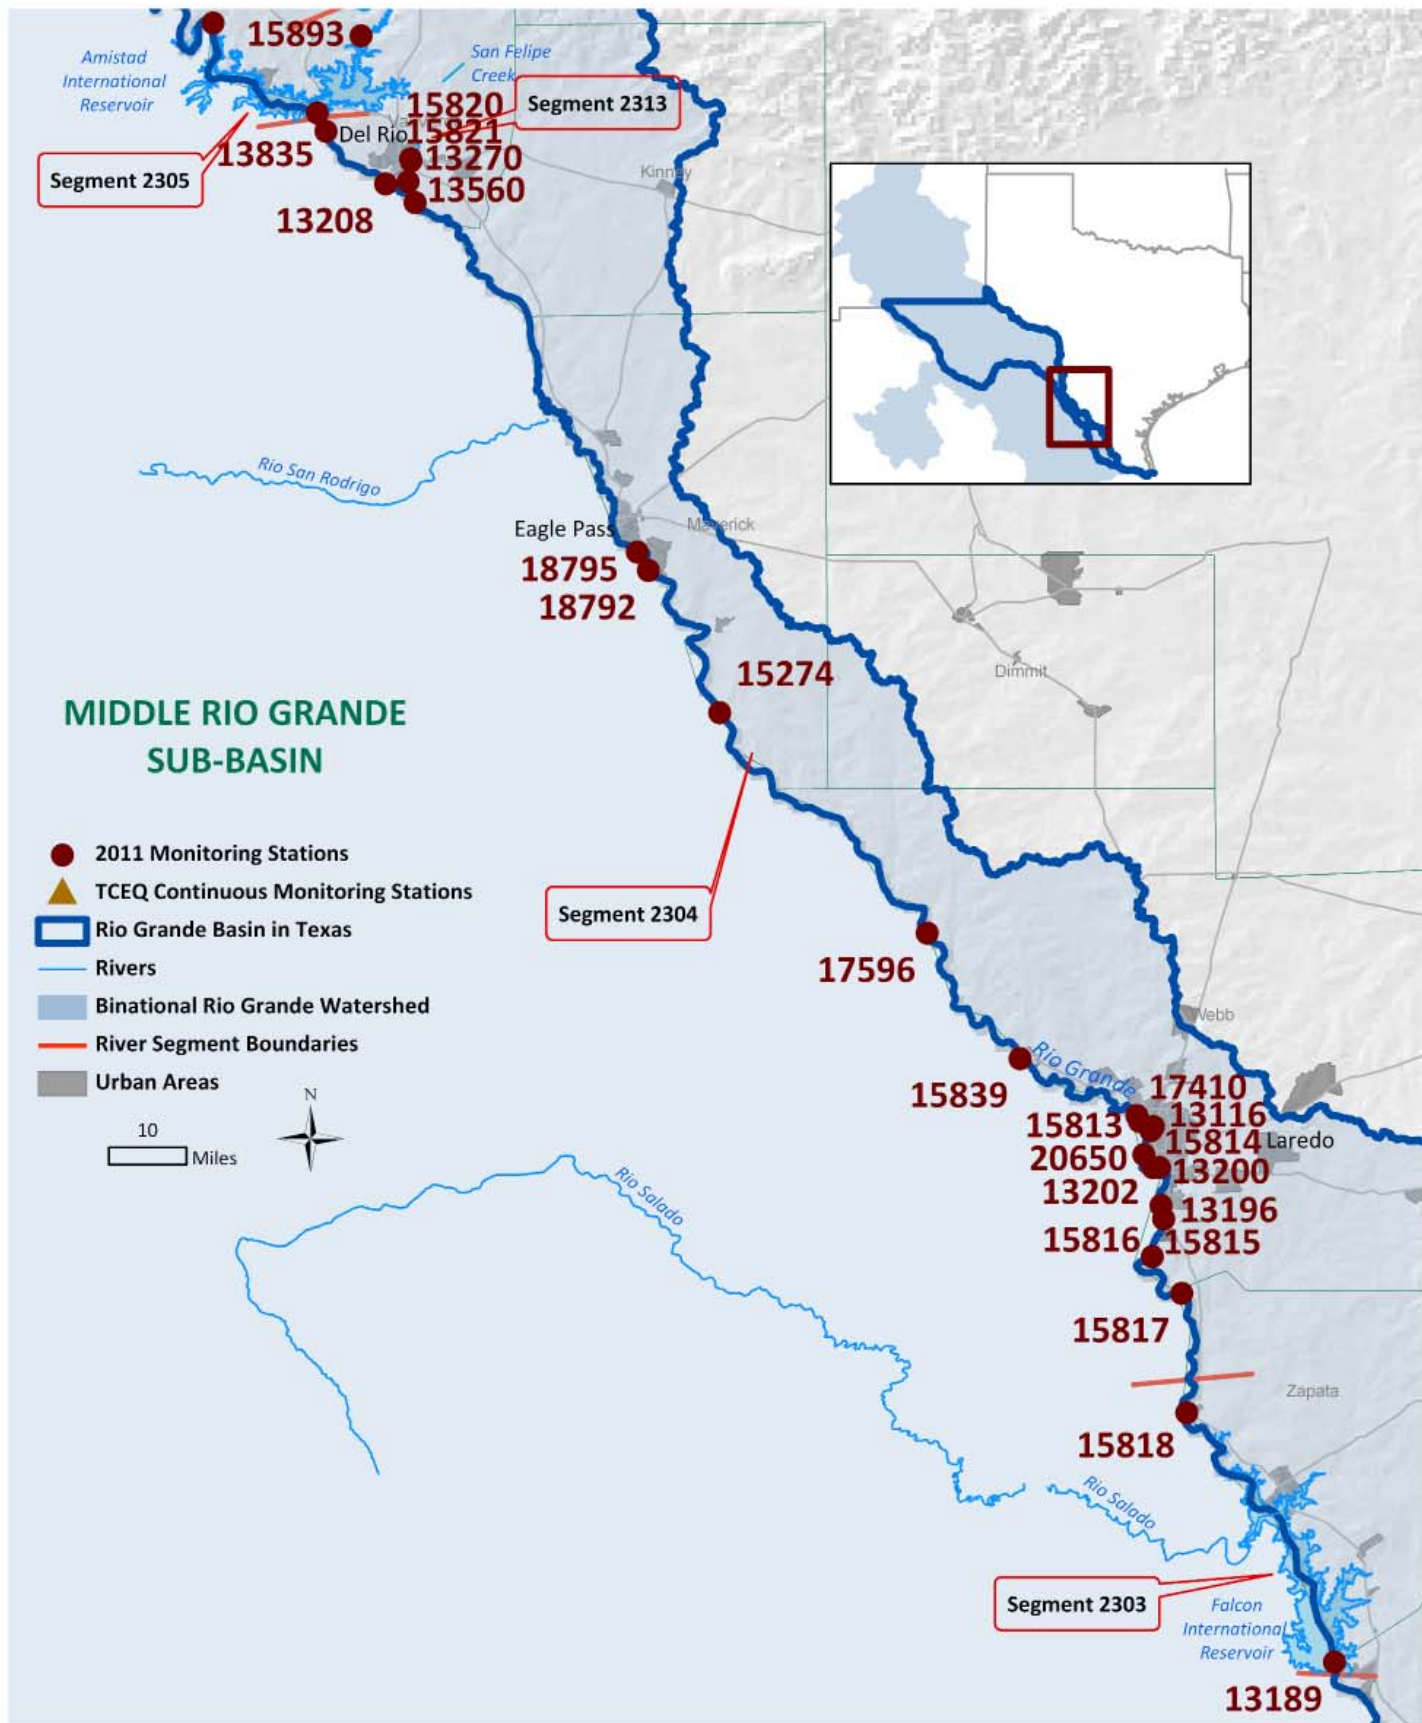
Figure 8. Middle Rio Grande Basin Station Map

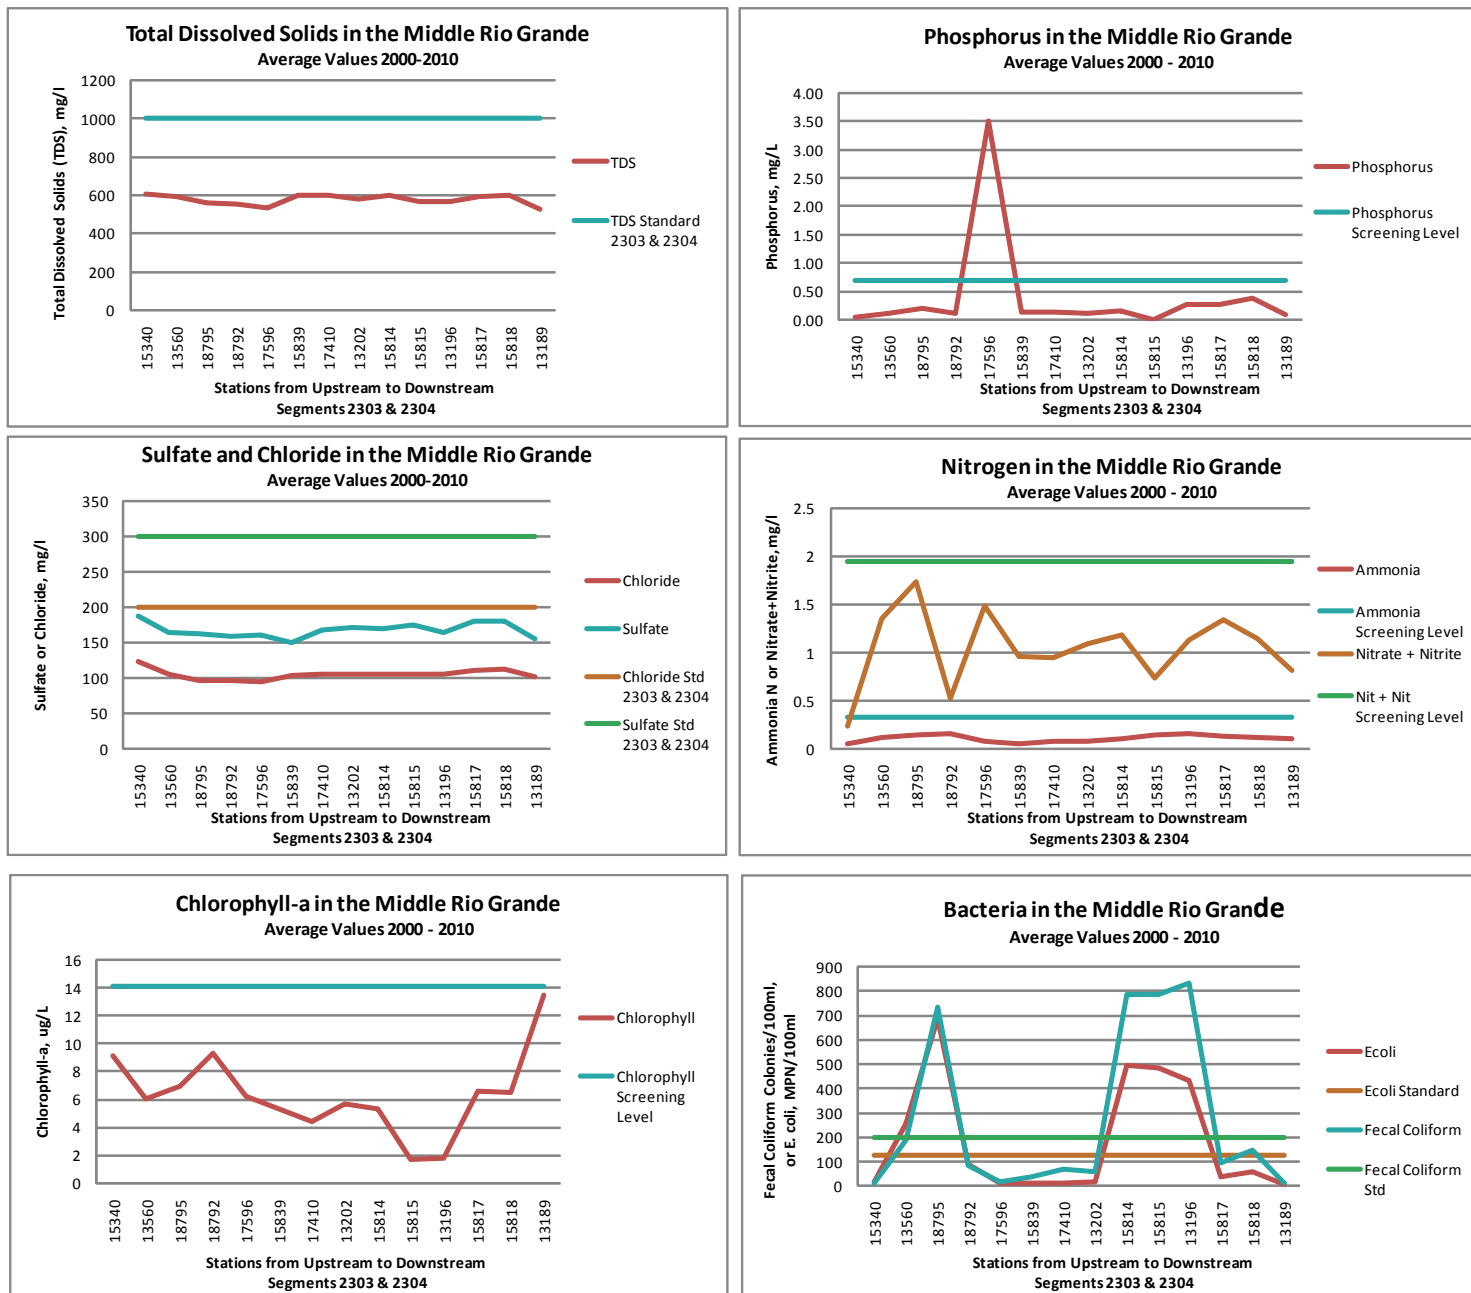
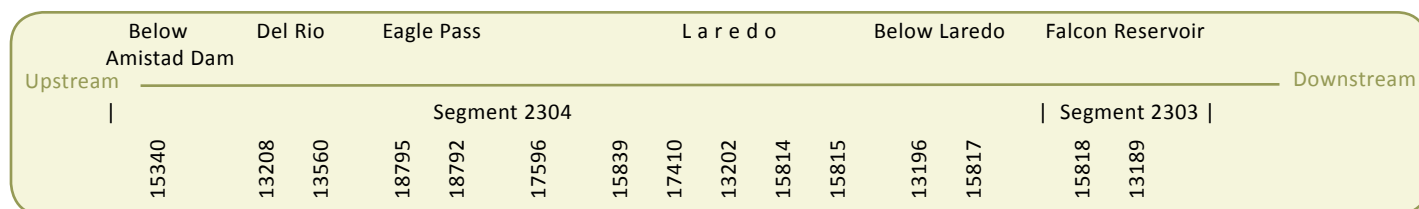
Figure 9. Graphs of major water quality parameters in the Middle Rio Grande

The graphs above show 11-year averages of TDS, sulfate, chloride, phosphorus, ammonia nitrogen, nitrate + nitrite, chlorophyll-a, and fecal coliform and *E. coli* bacteria for 14 stations in the Middle Rio Grande, with the upstream-most stations on the left and downstream stations on the right. Standards or secondary screening level criteria show where certain parameters are high. Bacteria is the principal problem in the Middle Rio Grande, particularly in the Del Rio and Laredo areas.

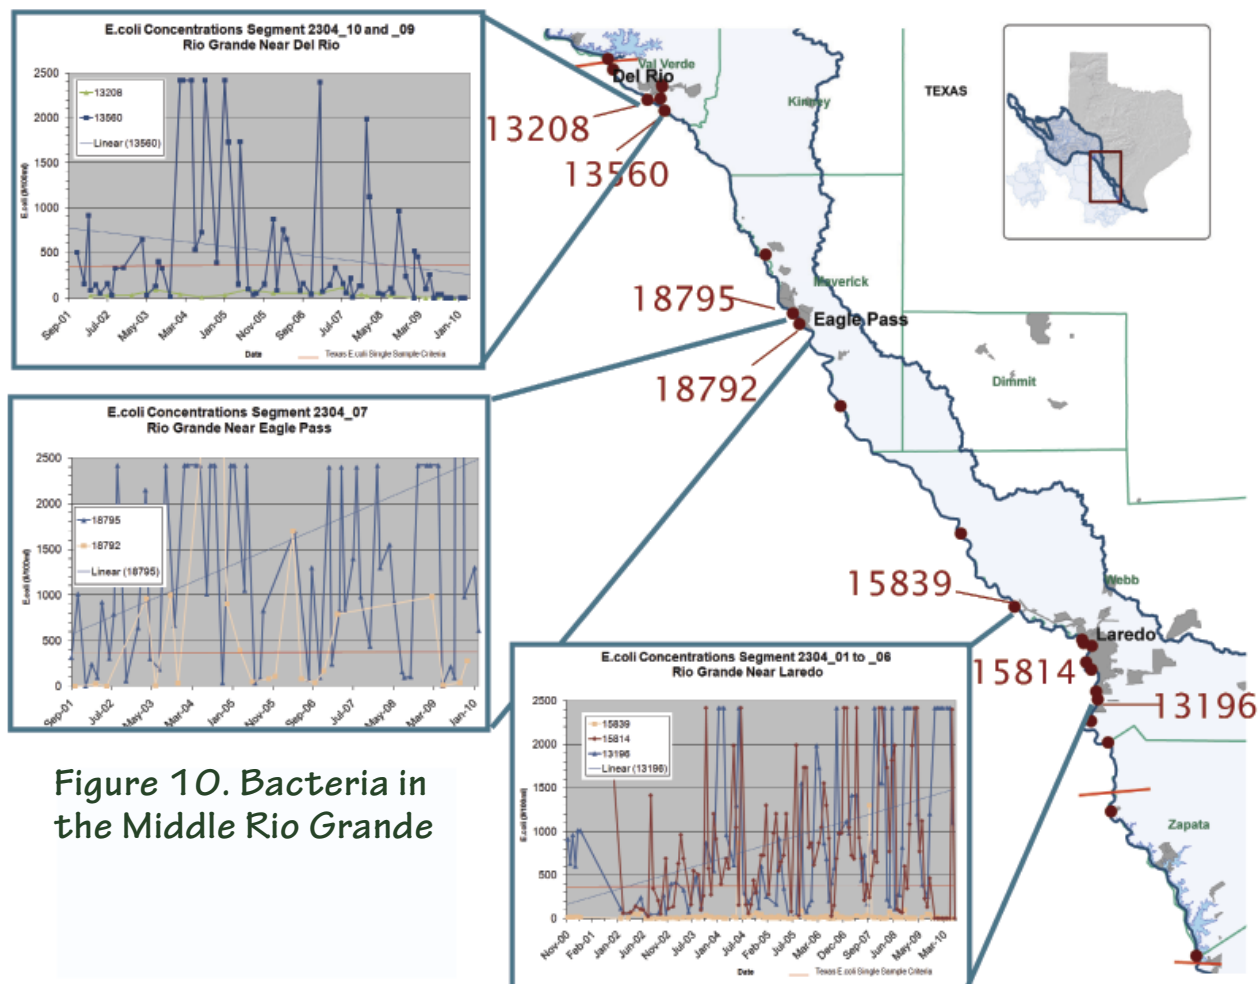
Figure 10. Bacteria in the Middle Rio Grande

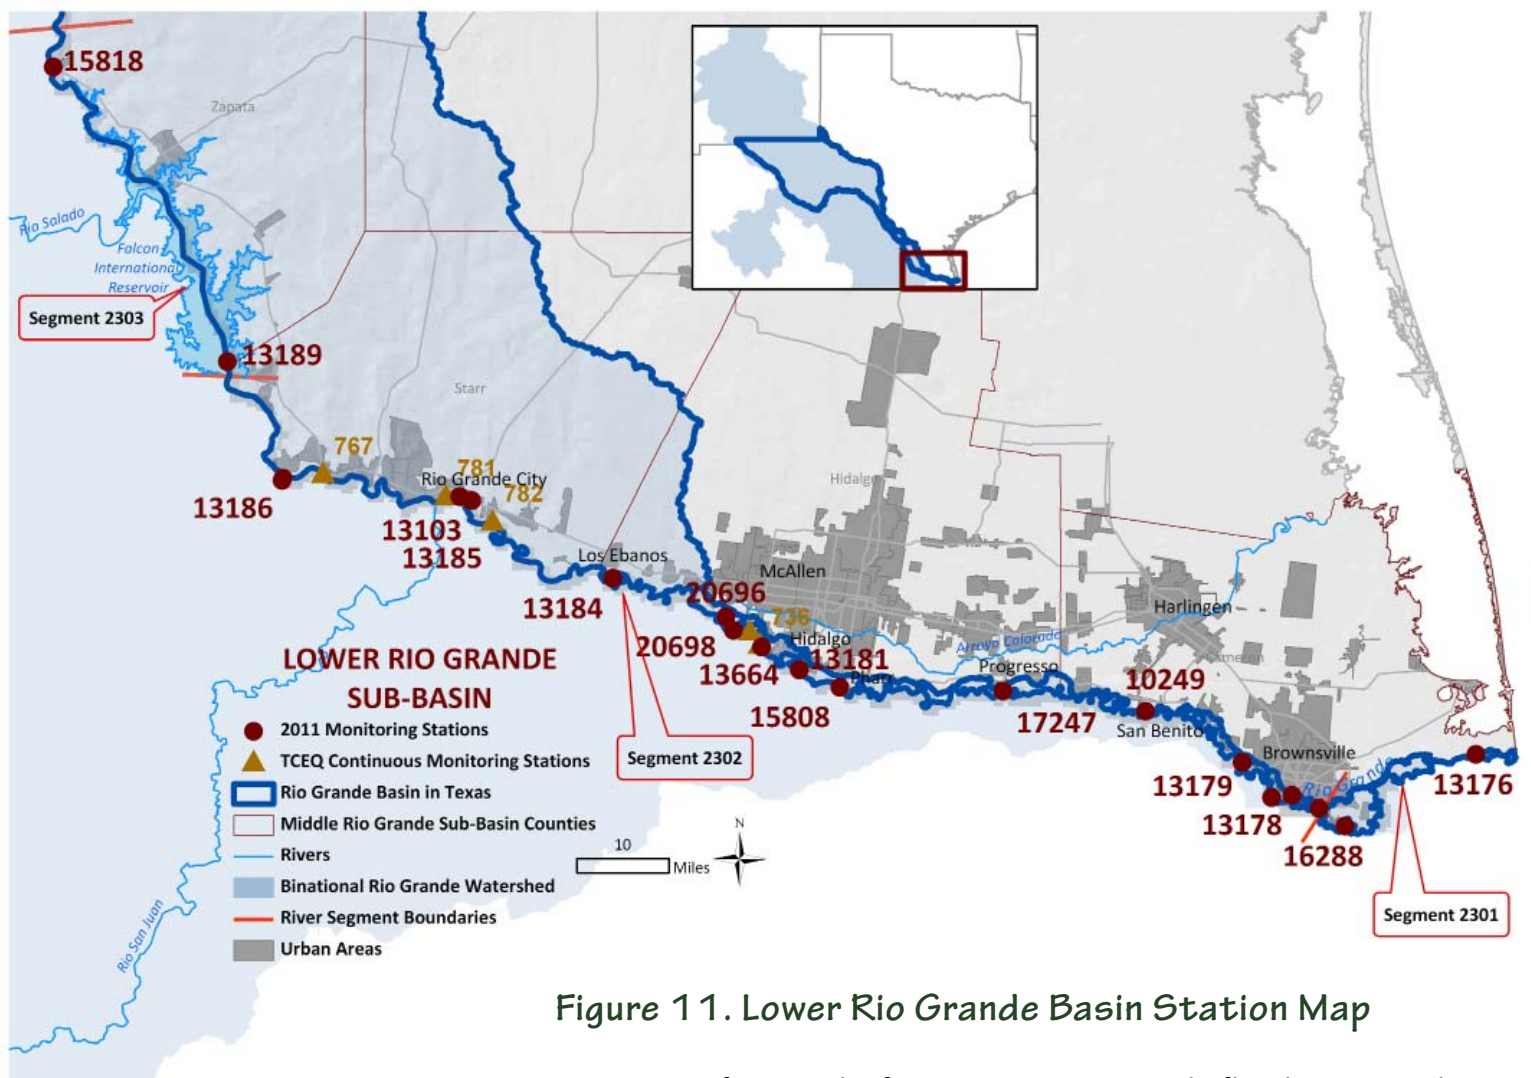
Figure 11. Lower Rio Grande Basin Station Map

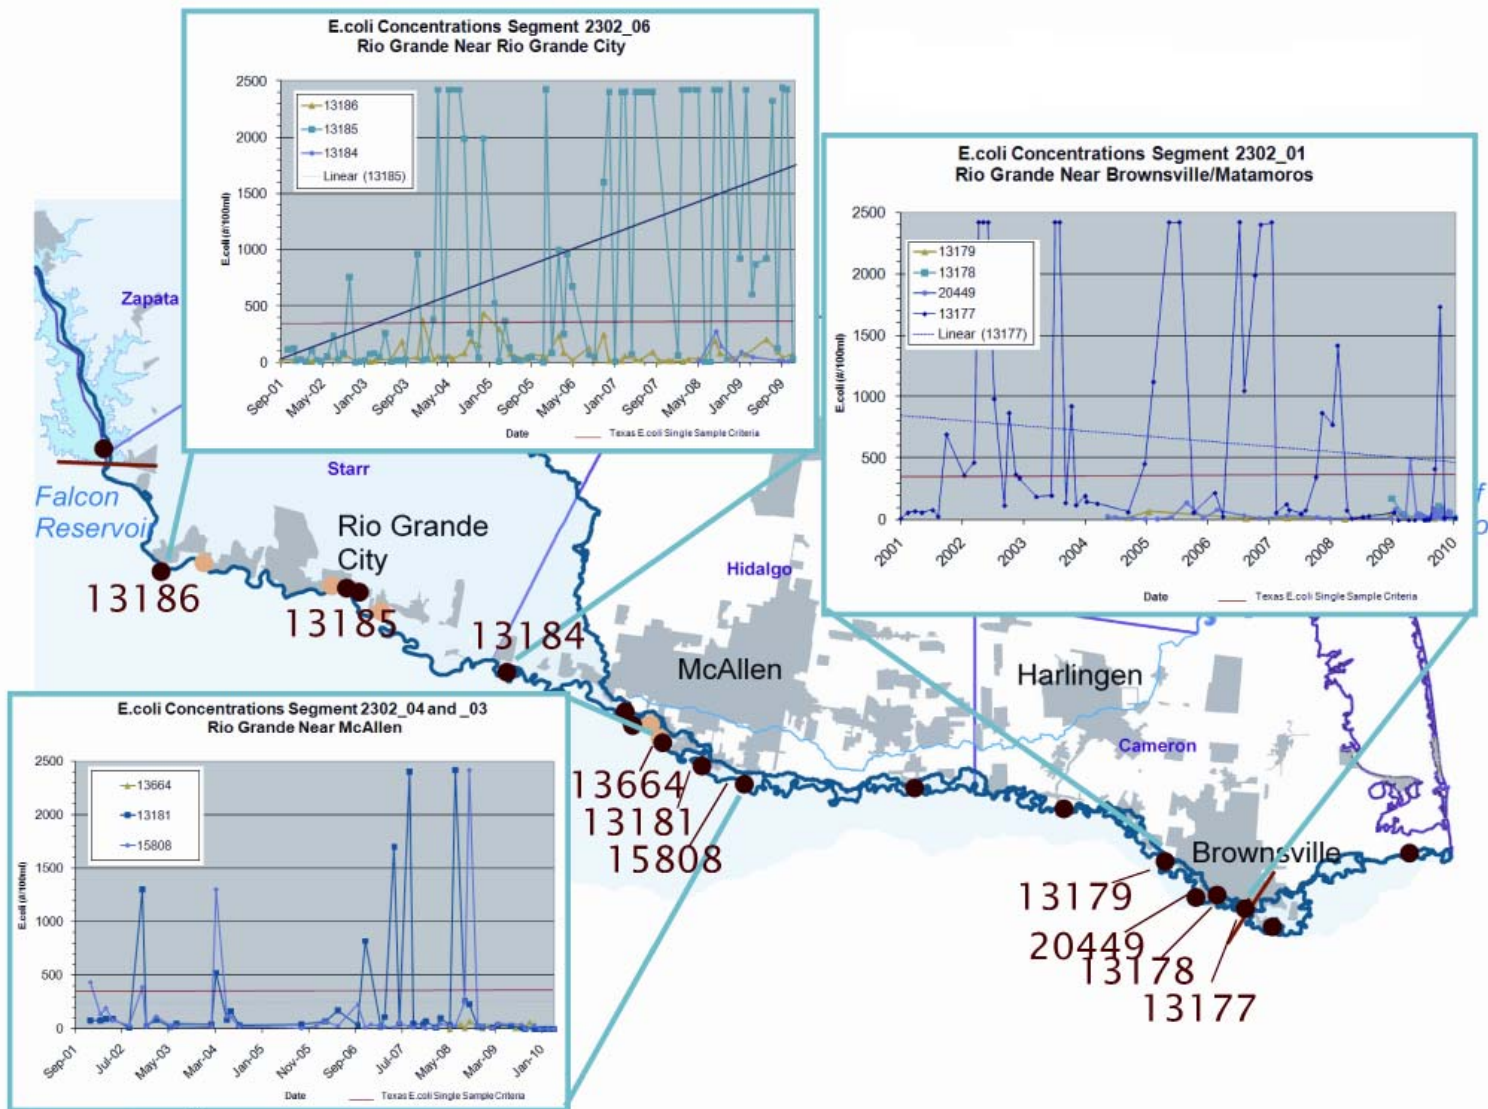
Figure 12. Bacteria in the Lower Rio Grande
