2011 Basin Highlights Report for the Rio Grande Basin in Texas

An update on Water Quality and Basin Activities

International Boundary and Water Commission, U.S. Section,
Texas Clean Rivers Program

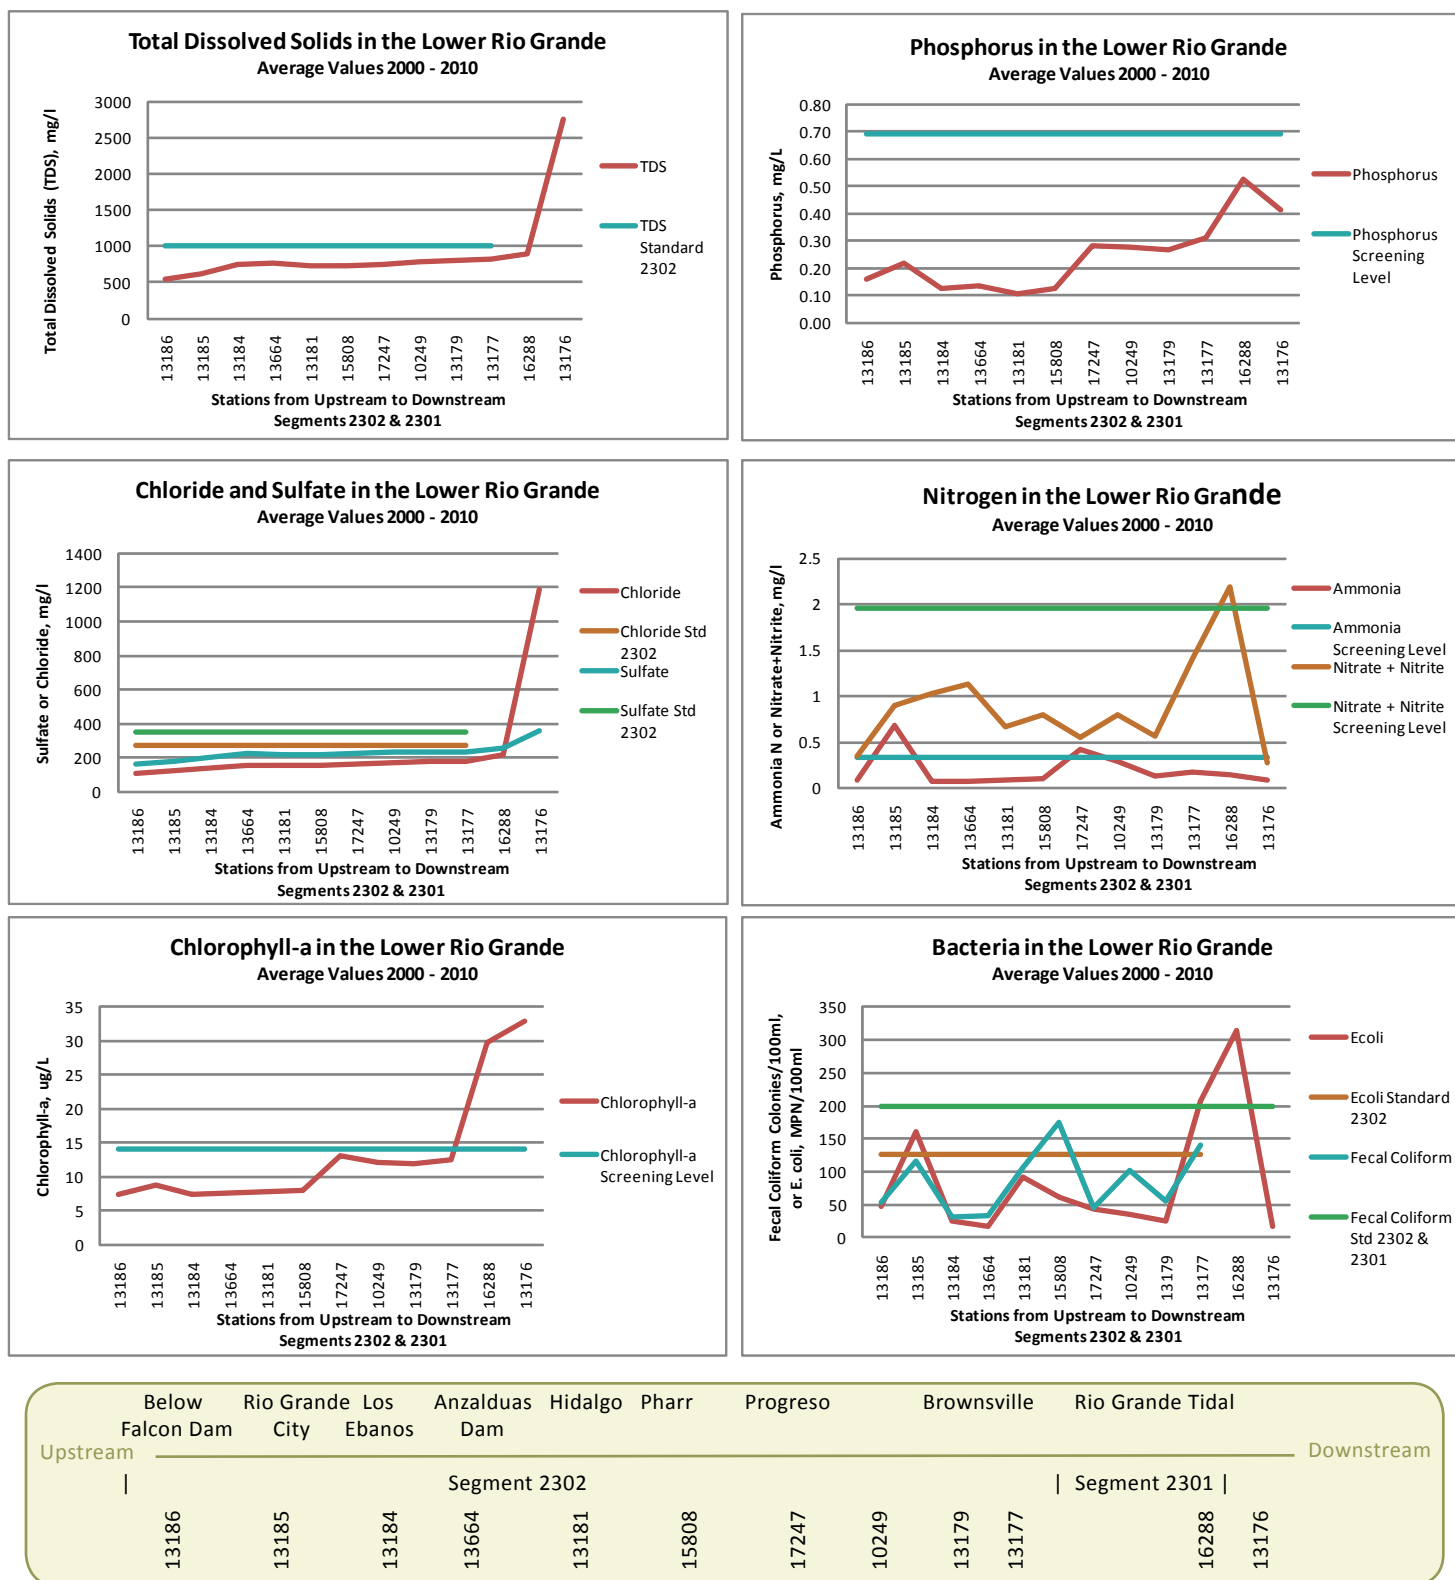
Figure 13. Graphs of major water quality parameters in the Lower Rio Grande
